Subject: On-Call Asbestos, Lead, Air Quality & Demolition Compliance
Agreement No.: 8.07-01 (18)
HazMat Inspection - Bridge No. 01686B, I-84 TR825 over Route 44 EB & Columbus
Boulevard, Hartford, CT
ConnDOT Assignment No. 514-6288
ConnDOT Project No. 63-654
TRC Project No. 289951.6288.0710

TRC performed a limited survey for hazardous building materials associated with the rehabilitation of Bridge No. 01686B, I-84 TR825 over Route 44 EB & Columbus Boulevard in Hartford, Connecticut. Results of the survey identified lead paint to be present on the structural steel/metal bridge components and railing supports at Bridge No. 01686B. Results obtained from TCLP waste stream sampling and analysis for leachable lead from the paint on the structural steel/metal bridge components and railing supports characterized the paint waste streams at Bridge No. 01686B as CTDEEP/RCRA hazardous waste. No detectable amounts of lead in paint were identified on the small yellow painted section of Pier No. 6, therefore any project paint waste stream would be non-hazardous, non-RCRA lead waste. Black tar between the expansion joints beneath the bridge were sampled and found to contain asbestos. Canvas betwee

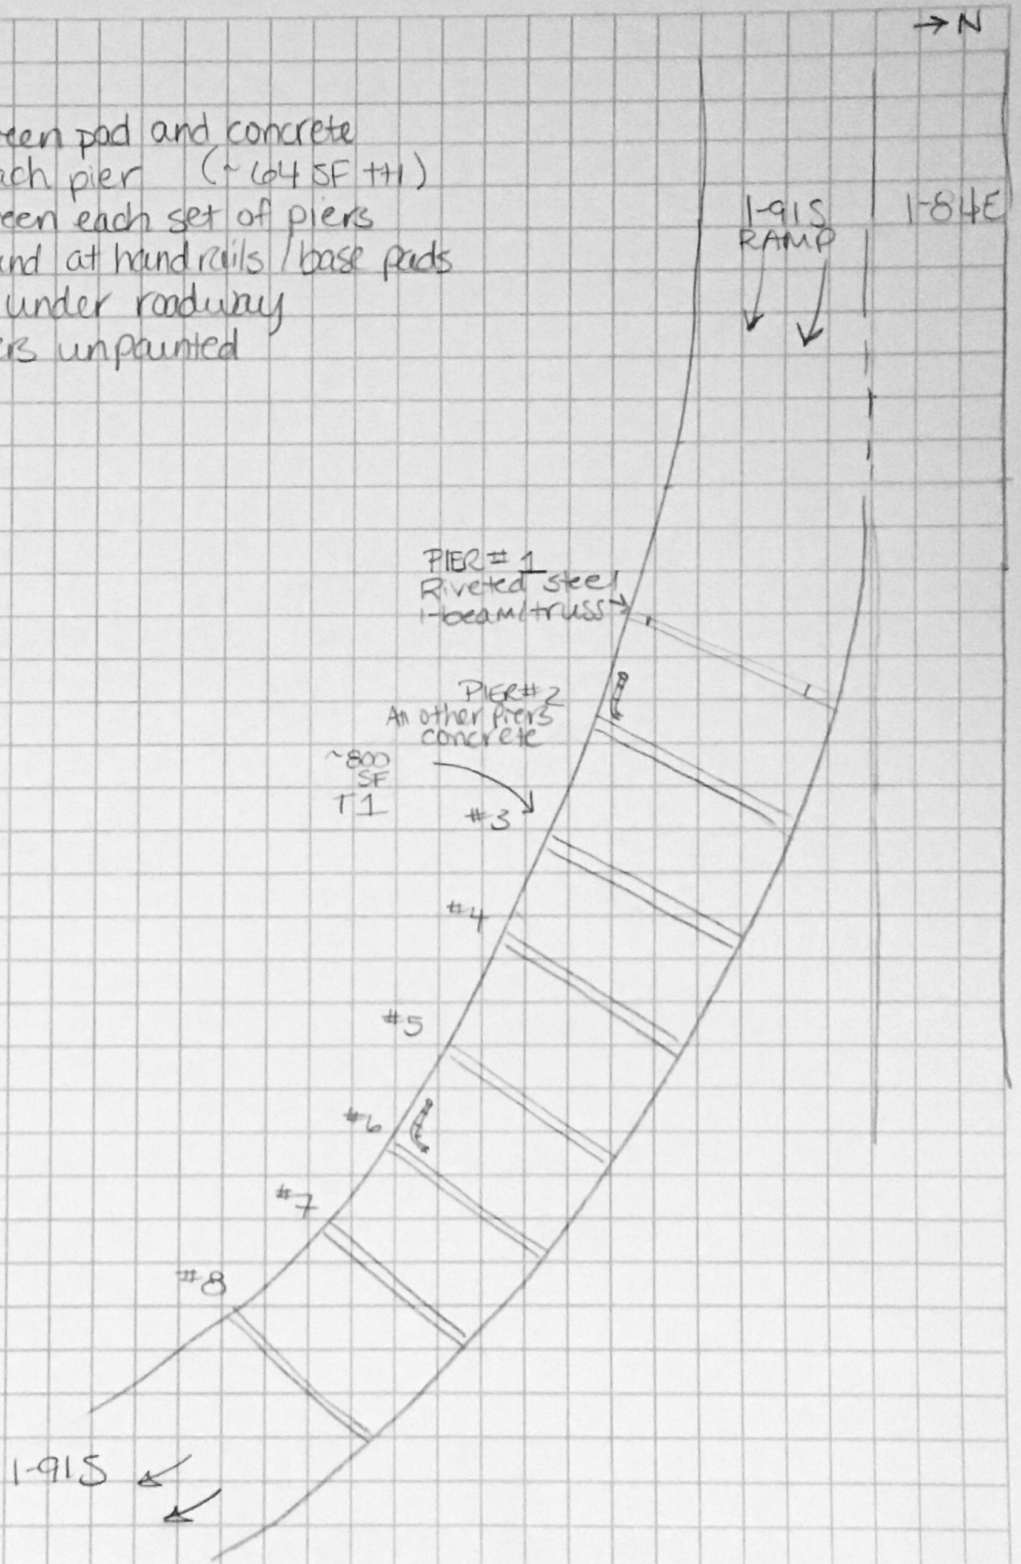
NOTES:

- ~8 LF C1 between pad and concrete piers → on each pier (~64 SF TH)
- ★ ~65 LF between each set of piers
- No caulk found at handrails / base pads
- steel beams under roadway
- concrete piers unpainted

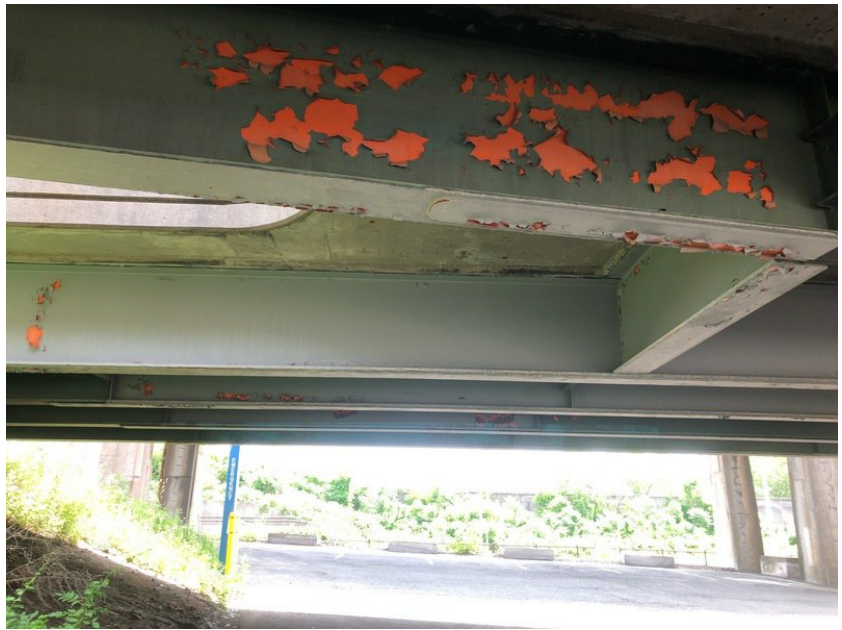
Pier 1 with I-beam where the first TCLP was sampled. This I-beam is ~200 sq ft.
